Building-integrated photovoltaics

An investigation of solar modules as ventilated curtain
wall facade depending on the specific rear-ventilation
and insulation

Masterthesis

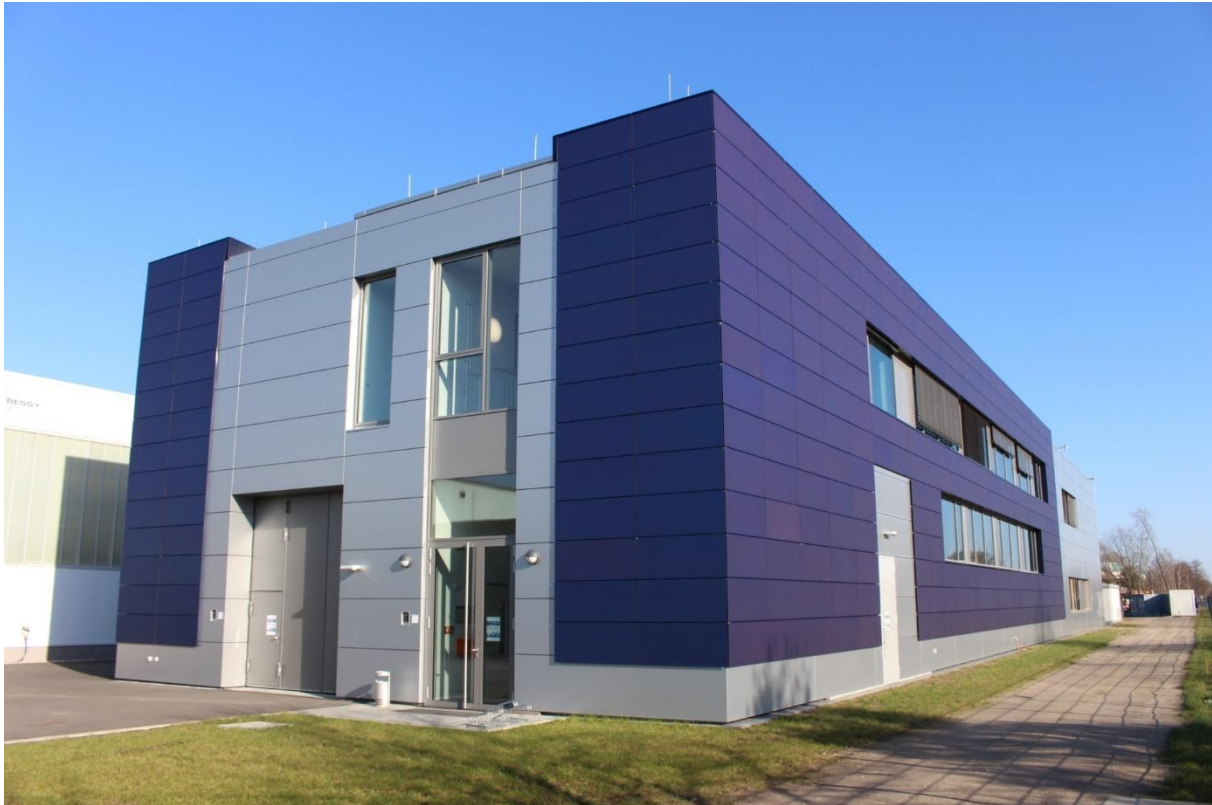
Besides all the facilities on the inside, an important research project is located on the outside. 360 fully integrated thin-film solar modules are part of a BIPV system, which cover a large area of the facade. That is why this new building is called Living Lab for Building-integrated Photovoltaics. The module areas which envelop the facade can be seen in the following Figure 2.

Figure 2: HZB Living Lab for Building-integrated Photovoltaics (South-West view)

These frameless and colored PV modules function as ventilated curtain wall facade with the ability to harvest solar energy. The modules are installed in three different facade orientations: South, West, and North. In the south facade 248 modules are integrated, while the modules integrated in the West and North facade amount to 56 respectively.

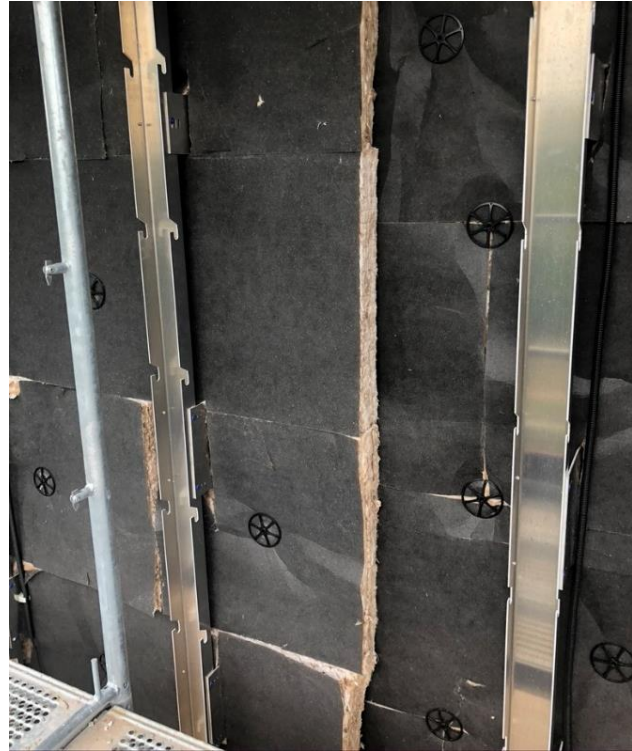
Figure 3: Schematic difference in the facade substructure

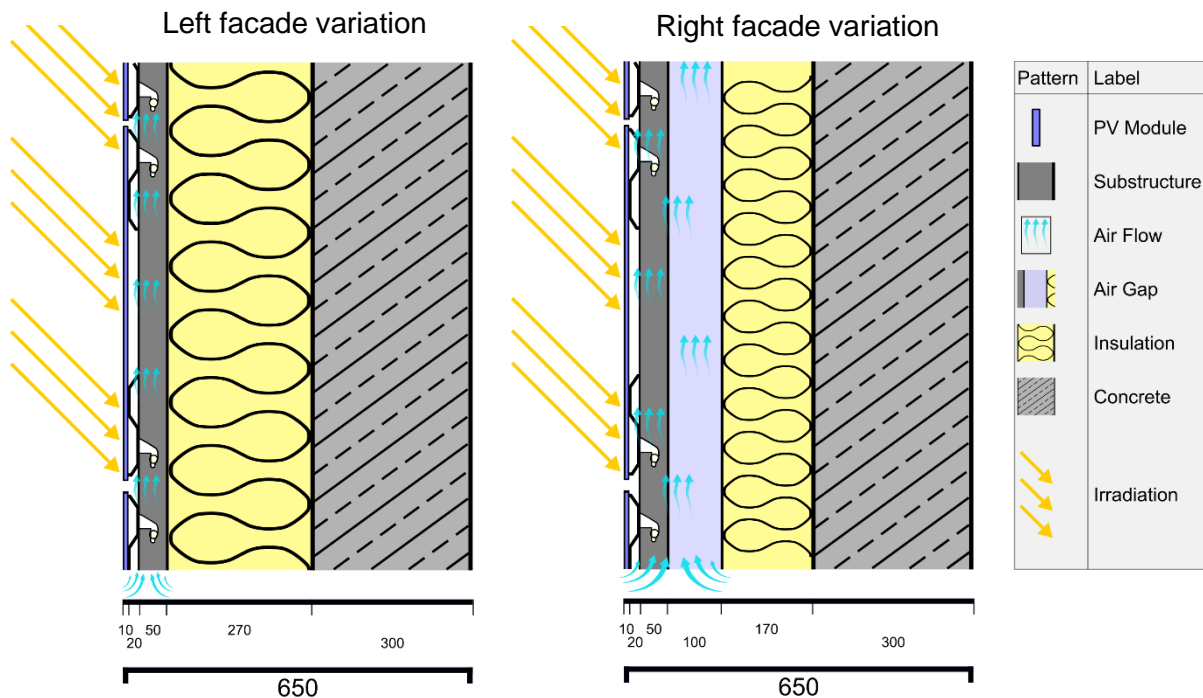
To further clarify the exact difference in the facade substructure, a schematic comparison of the variation is depicted in Figure 4. The attachment of the modules as well as the back rail system is shown in a simplified way for clarity. Note, that air flow is possible even between the individual beams of the facade substructure and not just in the right facade variation with an additional air gap between substructure and insulation. The overall air gap in the left substructure variation is 5 cm wide, while the overall air gap in the right substructure variation is 15 cm wide.

Figure 4: Schematic facade cross section of both variations of the module substructure

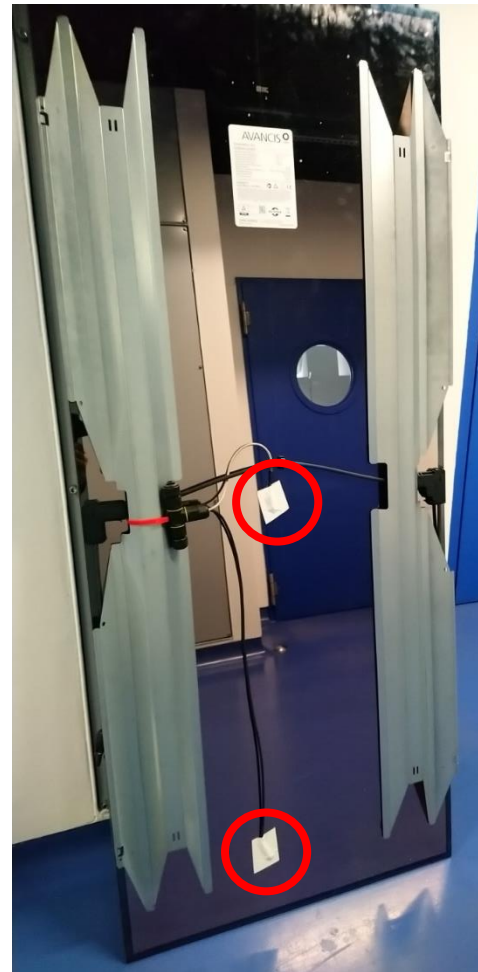
The module rear temperature is only measured on certain parts of the facade, just like in the area under investigation. Not every single module is temperature monitored. Only selected modules in proper distance to each other are equipped with a sensor to ensure maximum coverage of the area while using a small number of sensors. Some modules are equipped with two temperature sensors to show the difference between the center and edge temperature. The precise placement of each sensor is later shown in Figure 10.

Figure 5: Temperature sensors on the solar module rear side (circled in red)

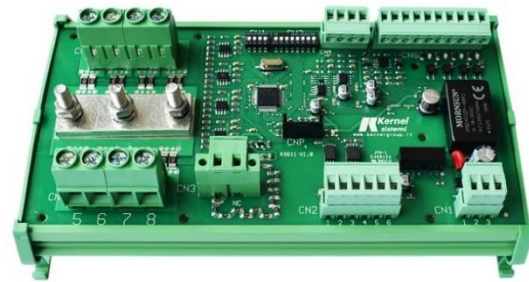
Each solar module is connected with other solar modules to so called strings. These strings are individually monitored by string monitoring devices (shown in Figure 6). These have to be integrated into the generator connection boxes (GCB), to provide sufficient protection for the electronics. A string monitoring device integrated in a GCB can be seen in Figure 7.

Figure 6: Kernel ST2 0825 string monitoring device

Two different string monitoring devices are used for the PV system. That is why it is important to note, which one is used for which string. There are eight Raycap ProSMS8 devices and three Kernel ST2 0825 devices in use. In the following, the specifications of the Kernel devices will be discussed since this work focuses on a specific part of the facade where only Kernel devices are used. When a string monitoring device is mentioned later, it refers to the Kernel product.

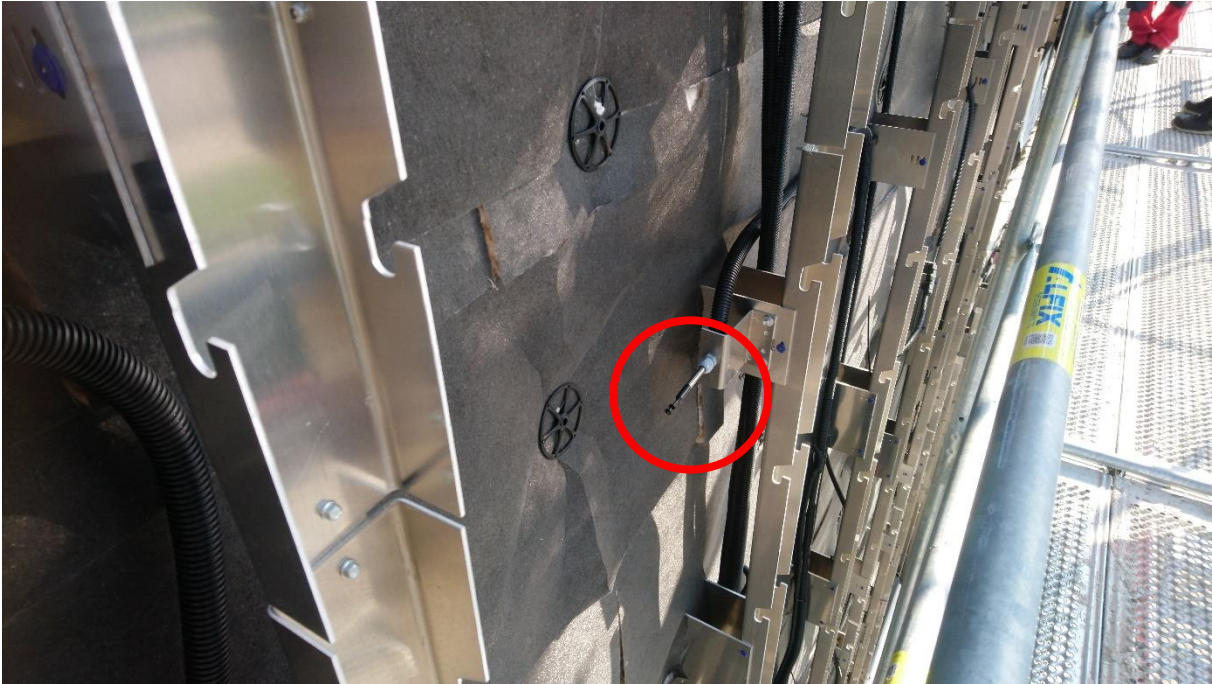
To quantify the rear-ventilation behind the solar modules, four air flow sensors are installed into the air gap. For this purpose, the SCHMIDT® Flow Sensor SS 20.500 has been chosen. This sensor can precisely measure the velocity of an air flow, even if the air is polluted by dust or various gases. The air gap behind the modules is not fully closed off to small particles or insects which is why some pollution has to be expected. As shown in Figure 8, the device gets attached to the module substructure and aligned so that the air flow hits the sensor in an orthogonal angle.

Figure 8: Placement of the air flow measurement device during the construction process

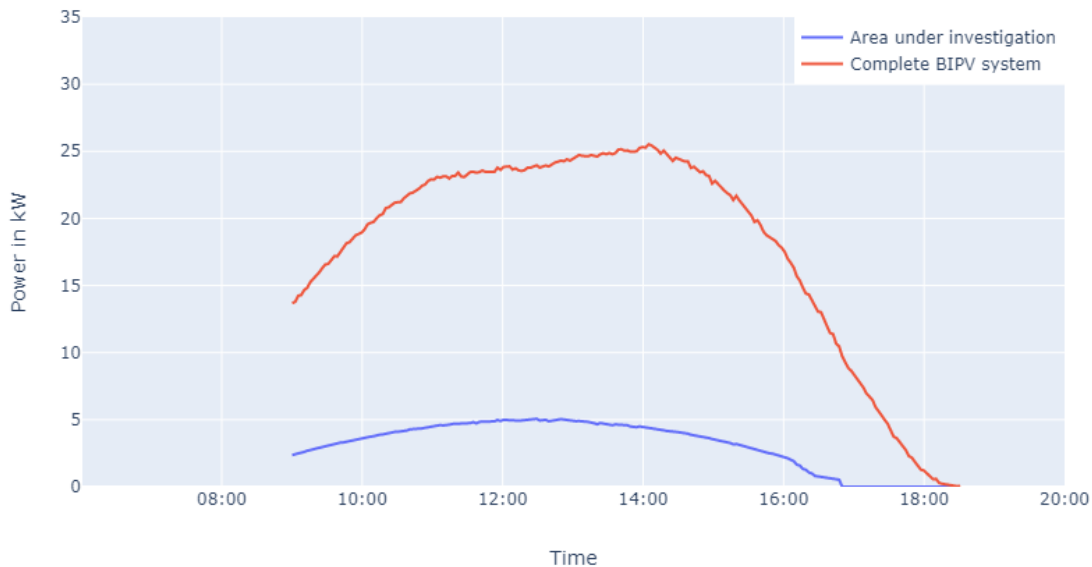
Since the inverters cannot portray string specific differences, the measurement by the additional string monitoring devices is used for the analysis of the PV power. Every following depiction of PV power refers to the DC power measured with these string monitoring devices. The following Figure 11 shows a comparison of the overall power from the complete PV system and the generated power from the area under investigation on an overall sunny day.

Figure 11: Comparison of data from the AC and DC measurement devices on the 24th of March

As already mentioned in 4.1, the measurement of the string monitoring devices does not start before 9:00 a.m. in the morning. After the measurements have started, a different course is observed. Most noticeable is the overall difference in power. Since the area under investigation is only a small part of the complete BIPV system, the generated power in this area is also only a fraction of the total PV power.

To determine the origin of the shape of the curve for the area under investigation in Figure 11, the following Figure 12 and Figure 13 show the influence of higher solar irradiation on a sunny day and lower solar irradiation on a cloudy day. Since the PV power is a function of the irradiance, a high similarity in shape is expected.

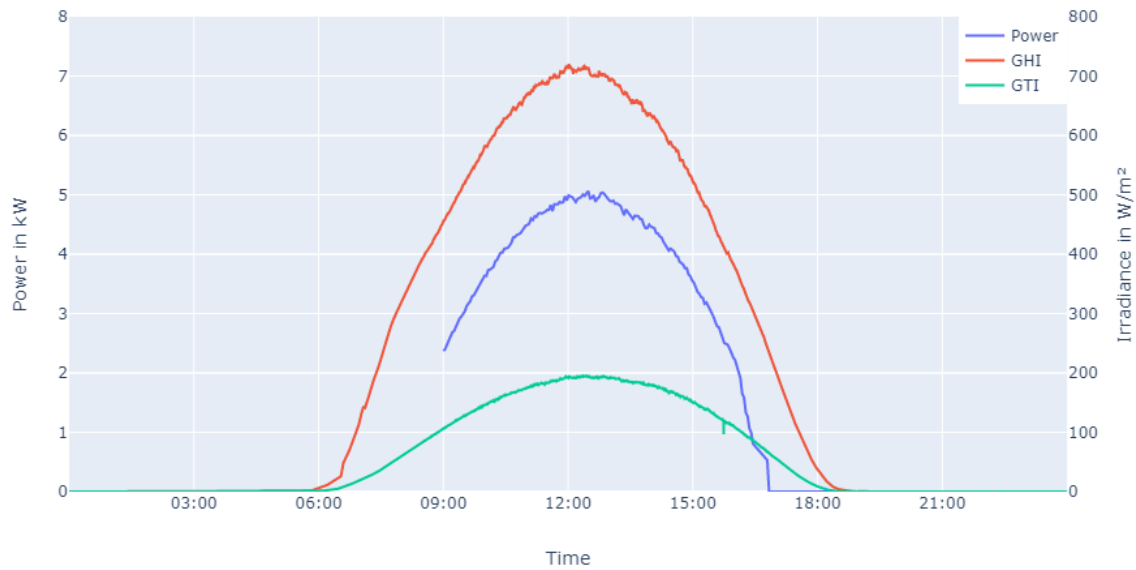
Figure 12: Total PV power in the area under investigation in contrast to the irradiance on the 24th of March

The generated PV power from the area under investigation shows a similar course to the depicted irradiances. However, the smaller fluctuations of the PV power do not pair with the fluctuations of the depicted irradiances. The same behavior is observed during a cloudy day. Figure 13 shows such a day with lots of clouds and high fluctuations in the global horizontal irradiation. These high fluctuations cannot be found in the course of the measured PV power.

The comparison of Figure 12 and Figure 13 clearly shows the dependency of the PV power from the irradiance. As already mentioned in chapter 3.1, the irradiance has the highest impact on the overall generated PV power, although other parameters can act beneficial or hindering towards it. The observed minor fluctuations in the PV power output cannot solely be attributed to the irradiance.

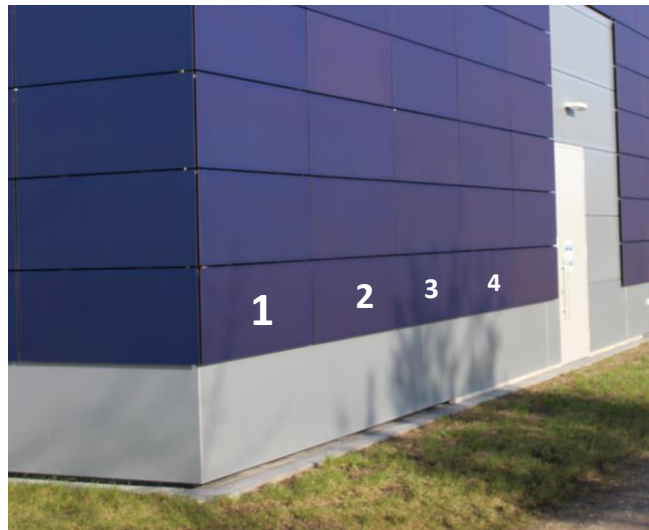
This phenomenon can be attributed to partial shading of the area under investigation. As shown in Figure 15 and Figure 33 in the appendix, a nearby group of trees is casting shadows during certain times of the day. The shadow moves over the lowest module of each string and therefore lowers the whole string power. Especially during winter month, where the angle of the sun is much lower, this phenomenon can clearly be observed. As the year progresses and the angle of the sun increases, the shadow is getting shorter and shorter until it only reaches the modules on the far left. An impact on the PV power could be observed at all times in the period under review.

Figure 15: Tree shadow over the area under investigation

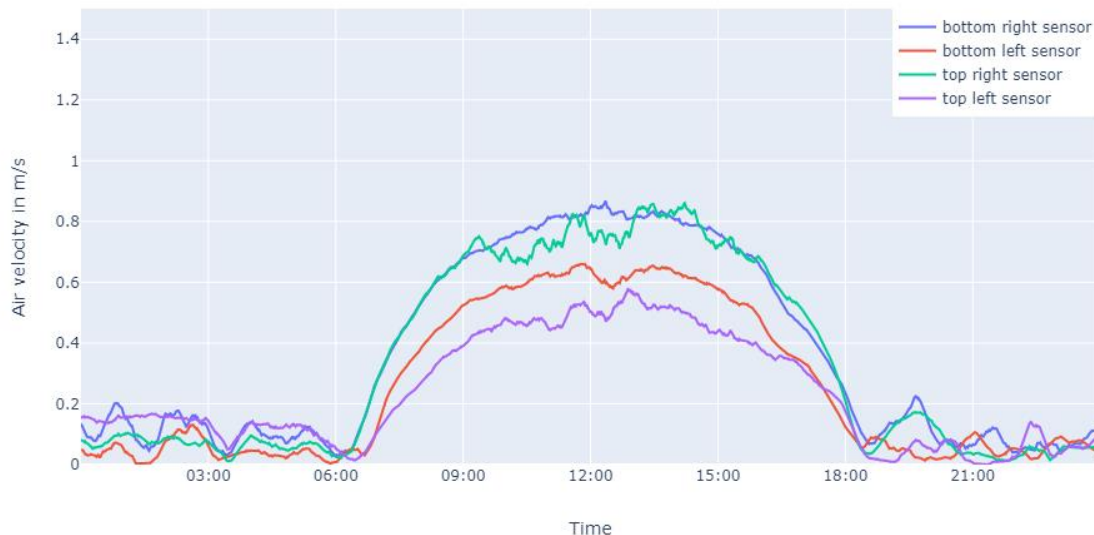
A moving average is applied to smooth out the fluctuations in the air velocity and enhance the comparability. This kind of average is commonly used to eliminate short but high fluctuations on data sets with long-term measurements. With the subset window size of 180 measurements which equals 30 minutes of data the curves get significantly smoother. In the following Figure 20, the average air velocity of the rear-ventilation is shown. Each part of the area under investigation is represented by the color code introduced in Figure 16.

Figure 20: Average air velocity of the rear-ventilation on the 24th of March

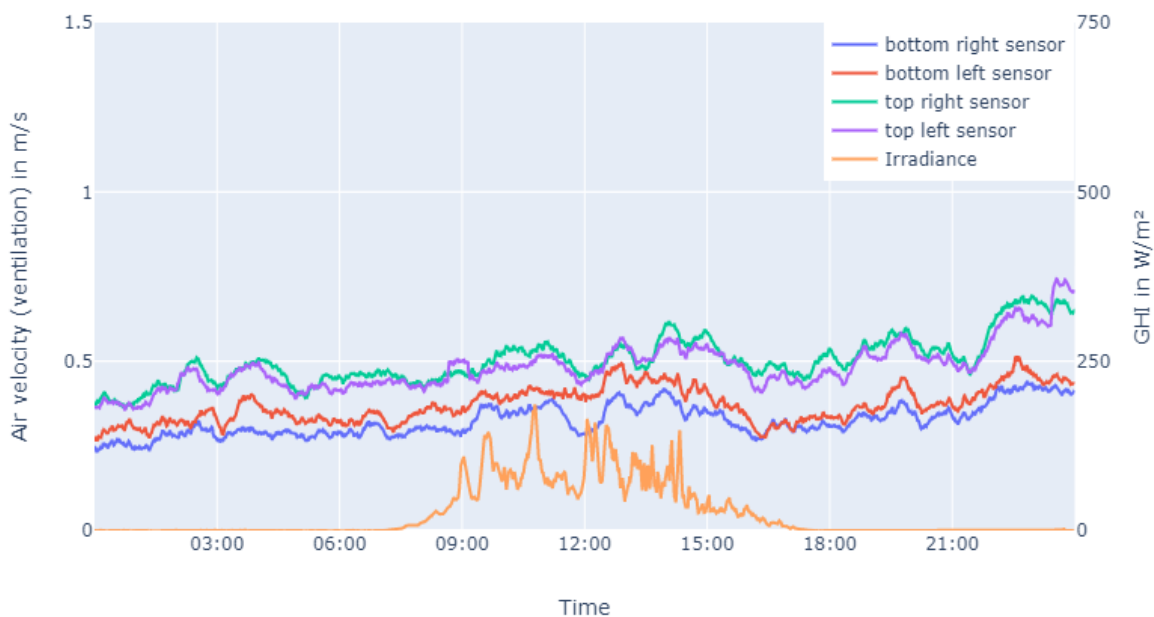
Figure 22 shows the same parameters as Figure 21 on a day with much more clouds and therefore much less irradiance. The maximum global horizontal irradiance rarely rises above 100 W/m². A significant fluctuation in the irradiance can also be observed which is caused by the cloud movement.

Figure 22: Average air velocity of the rear-ventilation and global horizontal irradiance on the 16th of February

On the cloudy day depicted in Figure 22 no major increase in the air velocity of the rear-ventilation can be measured during daytime. Over the whole day a small but steady increase of around 0.2 m/s can be observed by every sensor. But this overall increase shows no sign of being related to the irradiance because it is also observable during nighttime. Overall, the rear-ventilation seems unaffected by this small amount of irradiance.

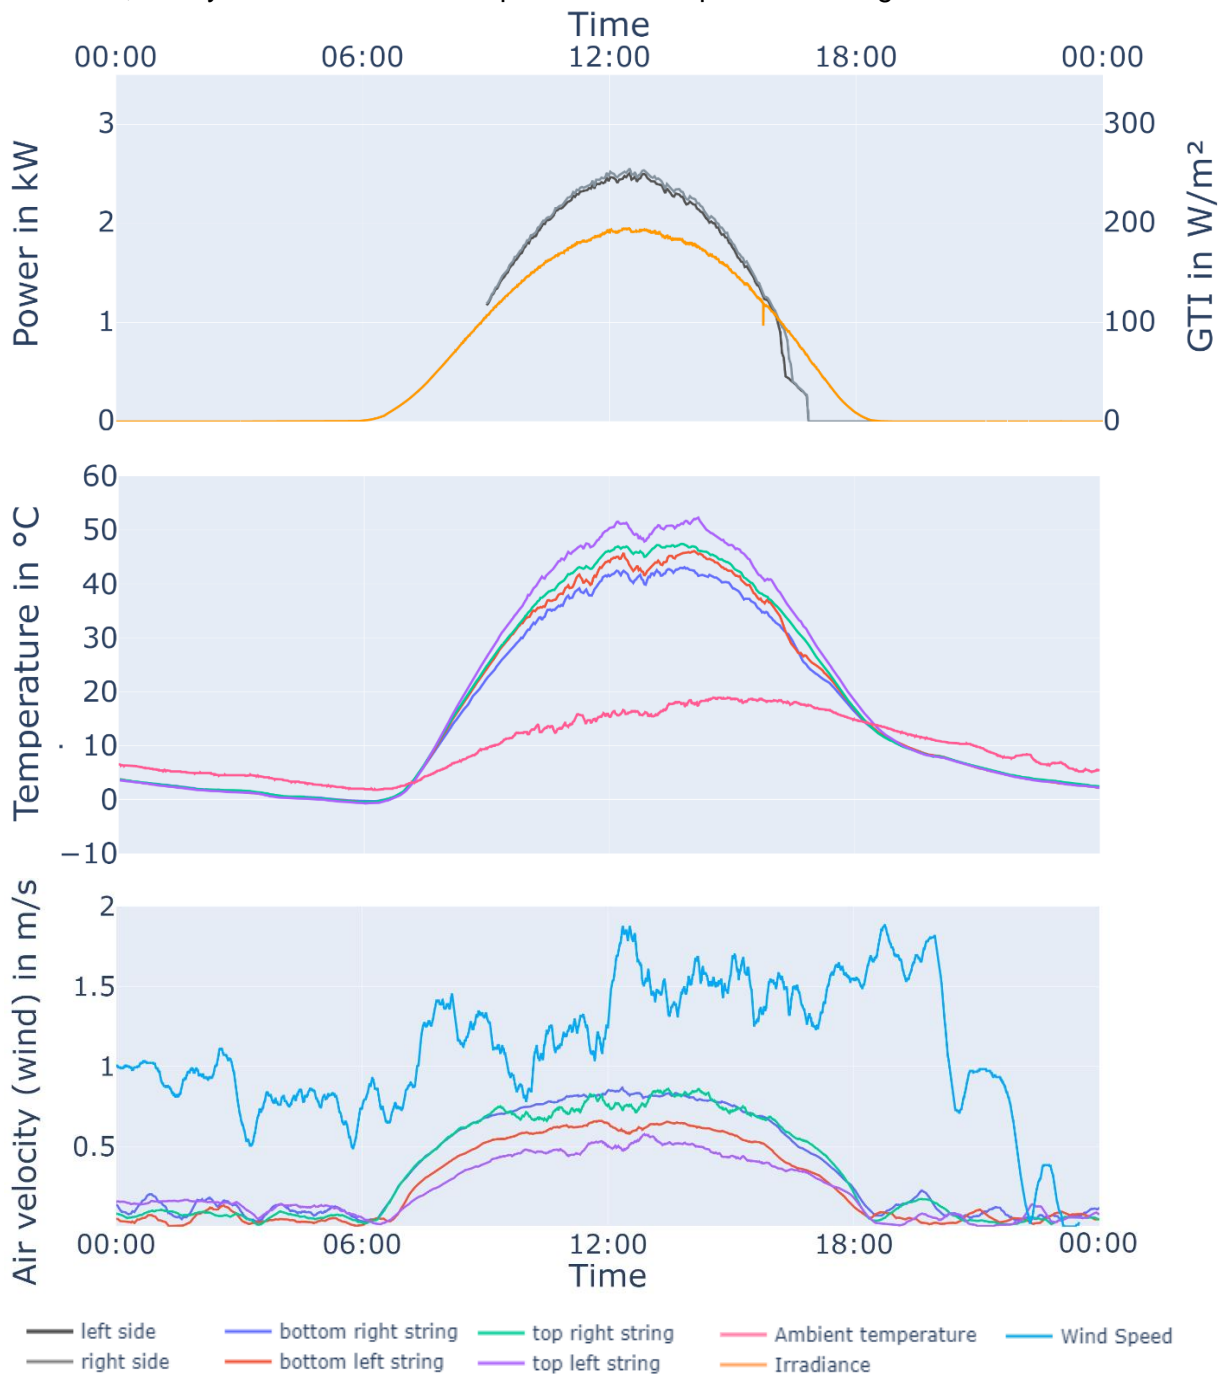
Most noticeable is the fact that even though differences in temperature and ventilation can be observed, nearly no differences in PV power can be spotted at first glance.

Figure 26: Overview over every measurement on the 24th of March

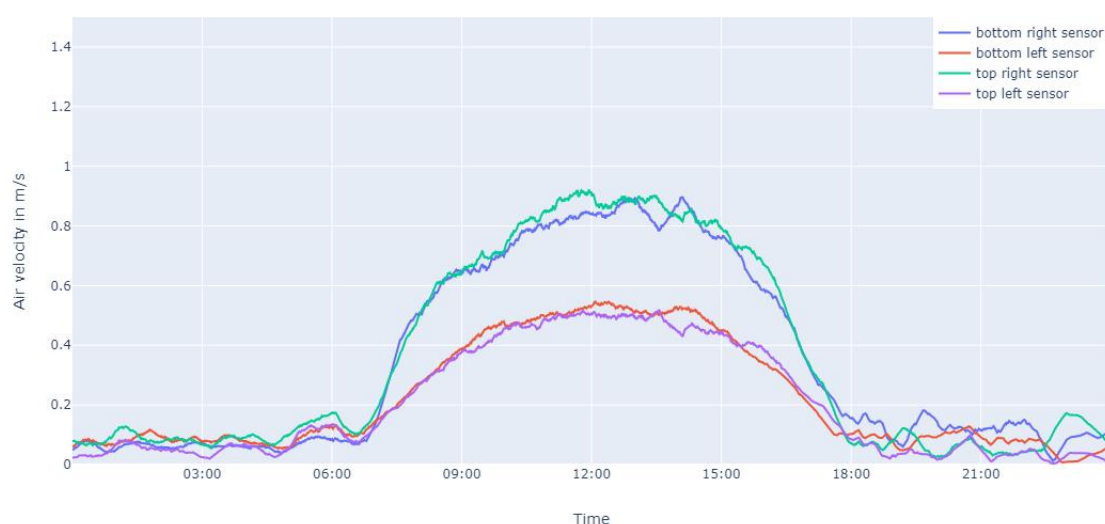
Usually, small to non-observable rear-ventilation can be measured during nighttime and if so, fluctuations can be observed. These fluctuations still can be observed during daytime, but mostly with less amplitude. The air velocity increases and decreases with the intensity of the solar irradiation as shown in chapter 5.3. High ambient wind speeds can also have a major impact on the rear-ventilation, but the occurrence during the measurement period is seen as an exception.

Figure 27: Average air velocity of the rear-ventilation on the 1st of March

The difference, which is shown in Figure 27, cannot be fully explained by the other measured parameters such as the module rear temperature. The reason could hypothetically be the smaller air gap, which possibly restricts the air flow. Even though the air gap is bigger than recommended minimal size of 2 cm for standard ventilated curtain wall facades without PV modules [14], proper air flow cannot be guaranteed. The module substructure, cables and measurement sensors could lead to a higher friction and therefore to a decrease in the air velocity. Additionally, some of the insulation mats could narrow down the air gap.

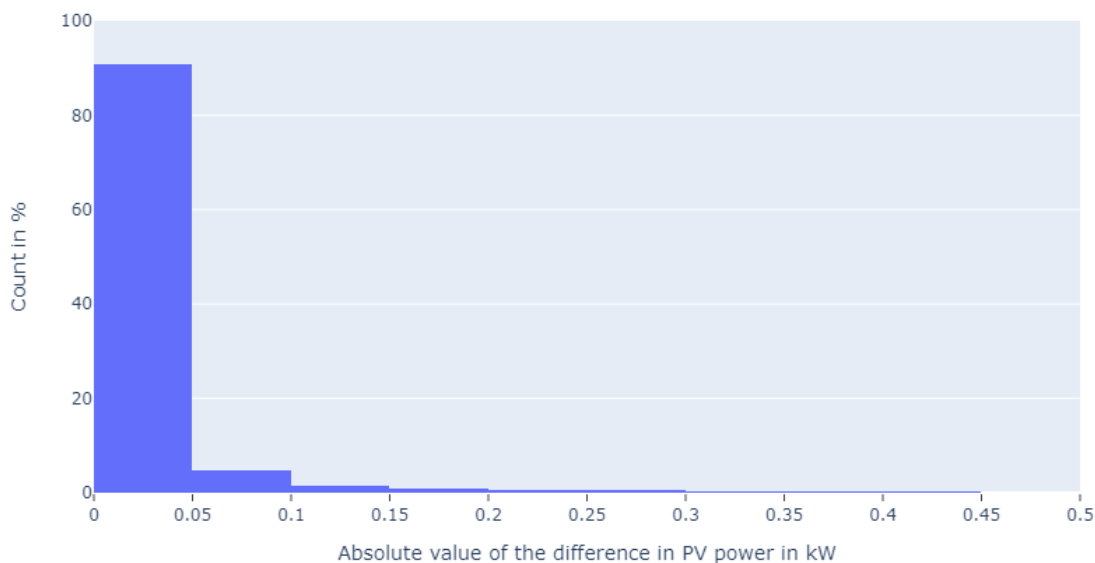
To conclude how often major or minor differences in the PV power occur, the following Figure 31 compares them to the total number of measurements over the course of three months starting at the 2nd of January. A high count in percent shows, that the depicted absolute difference in power has a high occurrence in the period under review. Note, that measurements only took place during daytime. The similarity during nighttime has not been included in the following figure, to assure a proper comparison only during operational hours.

Figure 31: Absolute difference in PV power from two different facade substructure variations (02.01. – 02.04.2022)

Since over 95 % of all measured absolute values lie within the range of 0 to 150 W difference of the generated PV power output, further investigation of this section has been done. Looking at the plain difference in the PV power between both facade substructures, a statement can be made, whether one of both module areas performs better. The following Figure 32 the difference in generated PV power from both facade substructure variations

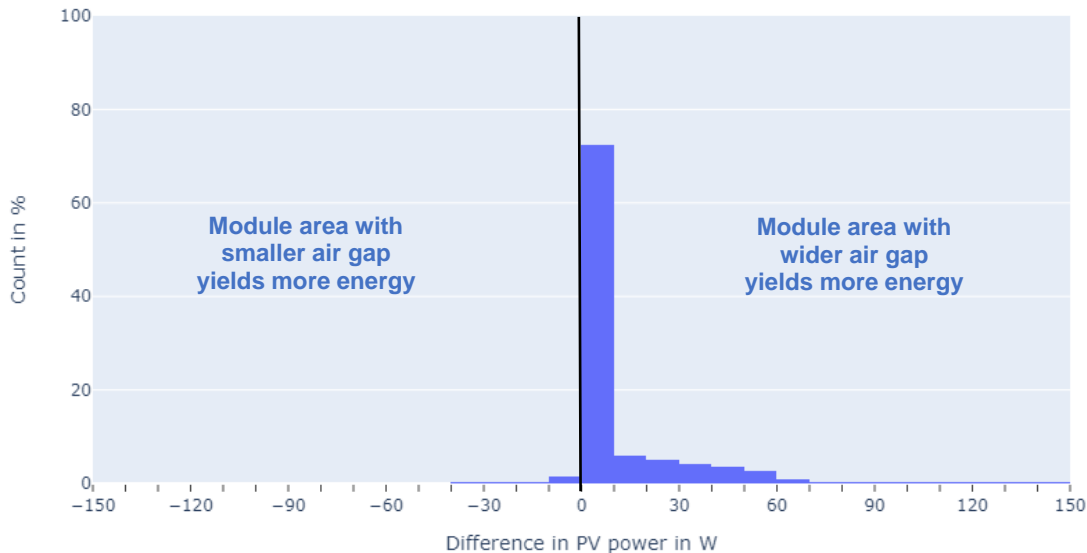
Figure 32: Difference in PV power from two different facade substructure variations (02.01. – 02.04.2022)

A clear shift towards the right side can be observed in this figure. Most of the measured differences in power are still in the smallest bin on the right side, although it has shrunk in size down to 72,3 %. Since all bins are clearly divided by positive and negative values, nearly all smaller differences have now been attributed to a higher power from the module area of the substructure with the wider air gap. Apart from the exceptionally high bin, the other bins on the right side all show a difference in power, which cannot be attributed to measurement uncertainties.

Although this assumption is not fully incorrect, a main contributing factor has been overlooked. As shown in Figure 29, fluctuations due to shading problems still can be observed in the early months of spring. A major part of the total difference in power still is caused by shading. Because the group of trees is located in the South-West of the area under investigation, the module area with the smaller air gap can still be shaded, when the shadow is too short to reach the area with the wider air gap.

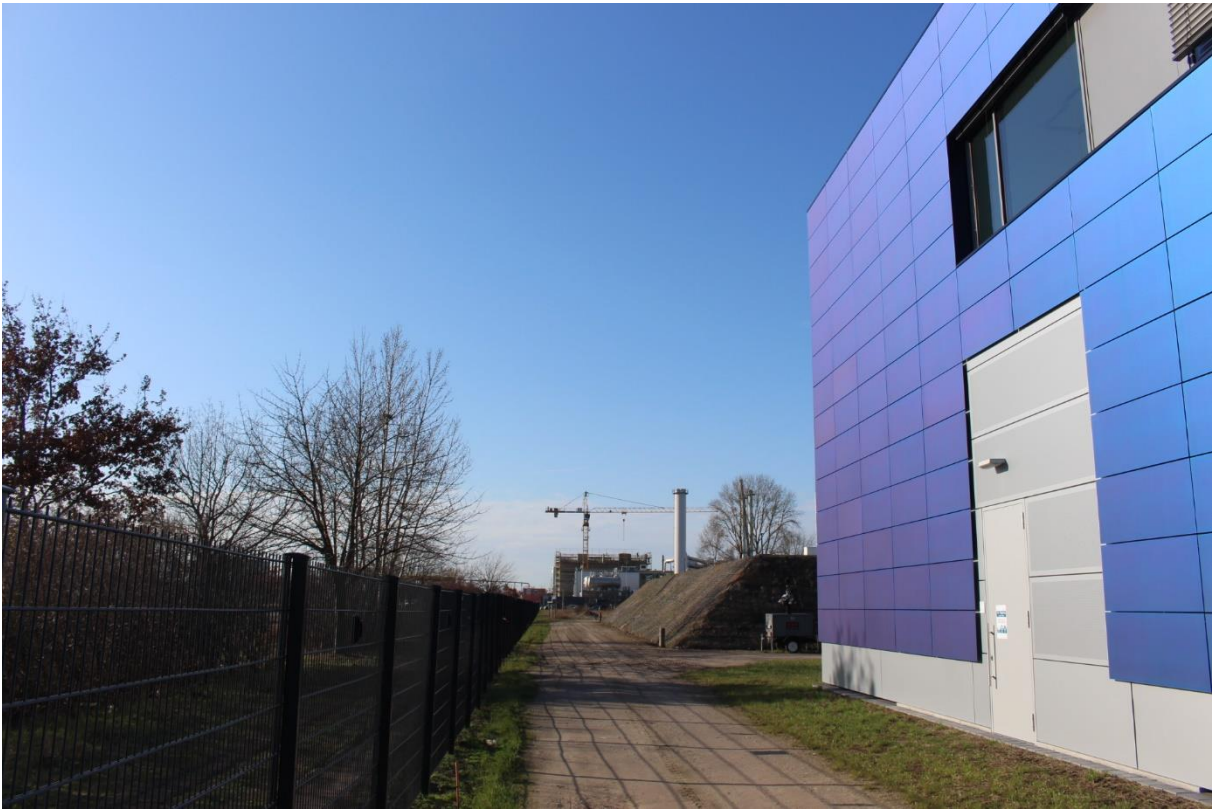
Figure 33: Group of trees (left) casting shadows on the area under investigation (right)
